Manhole Inspection Summary

Manhole # S51CC_014MH

Insp Date: **2/25/08 12:05 PM**

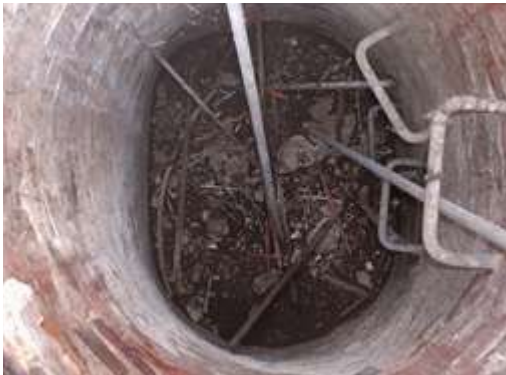
Top View

Frame Offset: **1** (in.) Condition: ☐ Sound ☐ Cracked ☒ **Leaks**

Condition: ☐ Sound ☐ Cracked ☐ Root Intrusion ☒ **Loose Brick** ☒ **Deteriorated**

Infiltration: ☐ None ☒ **Joint** ☐ Cracks ☐ Mortar ☐ Roots ☐ Wall
